HMS, Inc.
HAZARD MANAGEMENT SERVICES, INC.
207 McHenry Avenue
Modesto, CA 95354
(209) 551-2000 • (209) 575-5657 Fax

April 14, 2014

This letter contains the results of a limited asbestos inspection performed by Hazard Management Services, Inc. (HMS, Inc.) of the Billiard Room at Oak Park Senior Center for the City of Stockton. This inspection was requested in preparation for future floor renovation at the site. The inspection was performed on April 7, 2014 by Gordon Ridley. Mr. Ridley is a Cal/OSHA Certified Site Surveillance Technician and EPA-accredited Building Inspector. The methods used were reviewed and this report compiled by Chris Chipponeri. Mr. Chipponeri is a Cal/OSHA Certified Asbestos Consultant and EPA-accredited Building Inspector. See attached HMS, Inc. personnel certifications.

Oak Park Senior Center
Billiards Room
City of Stockton

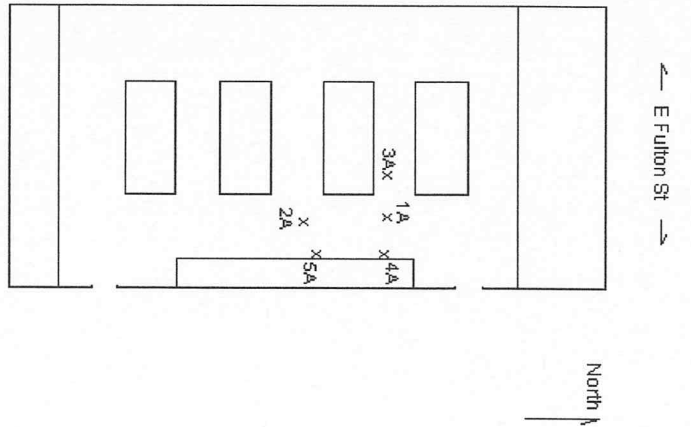
ATTACHMENT D

The 9" off-white with streaks vinyl floor tile and associated black mastic in the space was found to contain asbestos in both layers.

60x30' Room
9" VFT & Mastic

Samples taken from
damaged flooring tiles

Since more than 100 square feet of material may be impacted by the upcoming renovation, the floor will need to be abated by a contractor registered with Cal/OSHA as an asbestos abatement contractor. This work would be a Class II OSHA Activity and would require workers to have AHERA-Worker level training with one worker trained to the AHERA-Contractor/Supervisor level. The contractor will need to file a notification with the local Cal/OSHA office at least 24 hours prior to abatement beginning.
