**Environmentally Regulated Materials Survey Report
WATERFRONT TOWERS
501 and 509 West Weber Avenue, Stockton, California**

19 June 2020
Project No. 20-6023

Ms. Jamie Henderson Vilinskas
CITY OF STOCKTONECONOMIC DEVELOPMENT DEPARTMENT

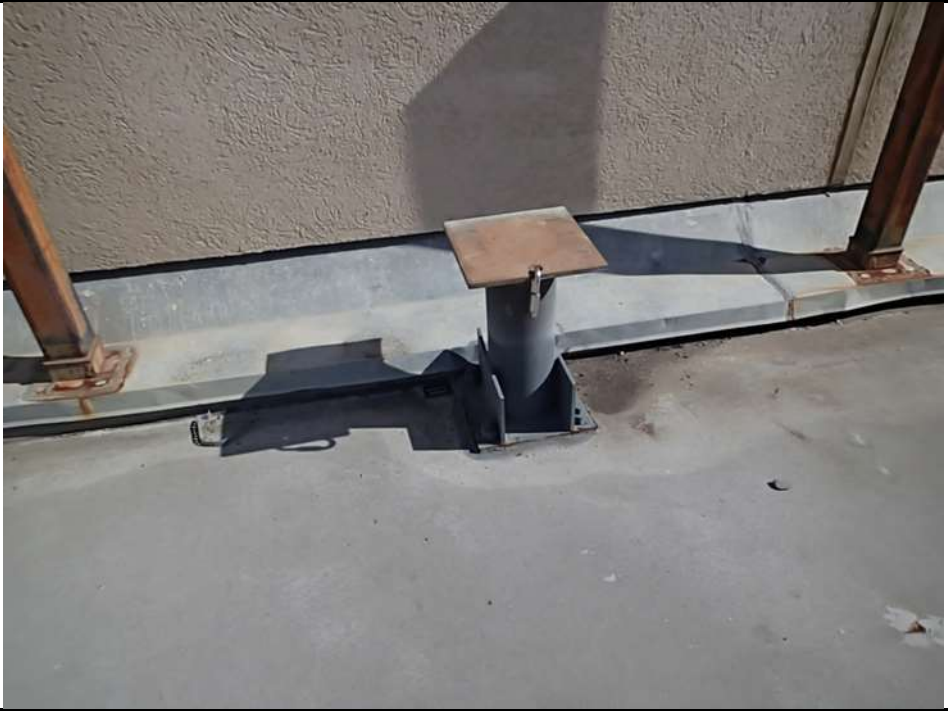
Client Name: City of Stockton	Site Location: 501 and 509 West Weber Ave., Stockton, California	Project No.: 20-6023
Photo No. 3 Description: LBP - 501 West Weber Ave: Window Washing Bosun Platform Anchor Post on Roof

Select painted surfaces and/or paint coatings and components within the Site were identified as LBP. The paint was observed to be in fair to intact (good) condition at the time of the assessment. If the LBP listed has the potential to be disturbed and or damaged during demolition activities, the contractor demolishing and /or disturbing the lead-based paint will be required to follow the US Occupational Safety and Health Administration (OSHA) regulations.

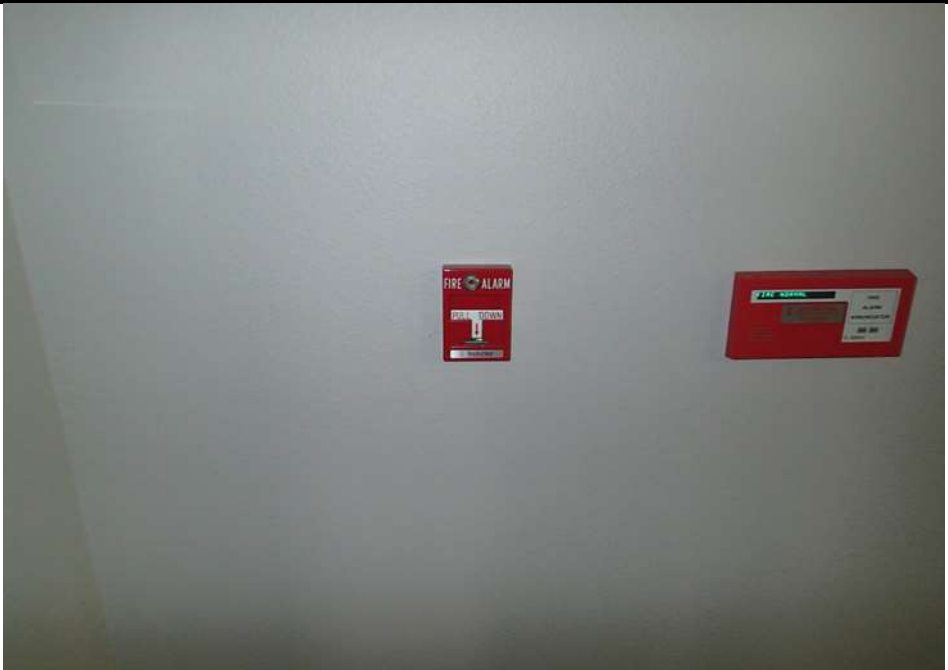
Photo No. 4 Description: LBP - 501 West Weber Ave: Fire Alarm Pull Station at Exit Stairs on All Floors

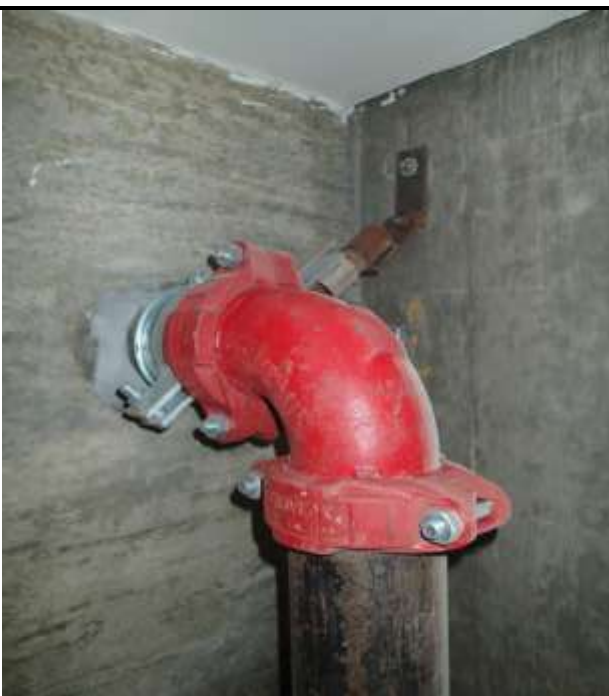
Photo No. 8

Description: LBP - 509 West Weber Ave: Sprinkler Pipe Elbows Throughout Building

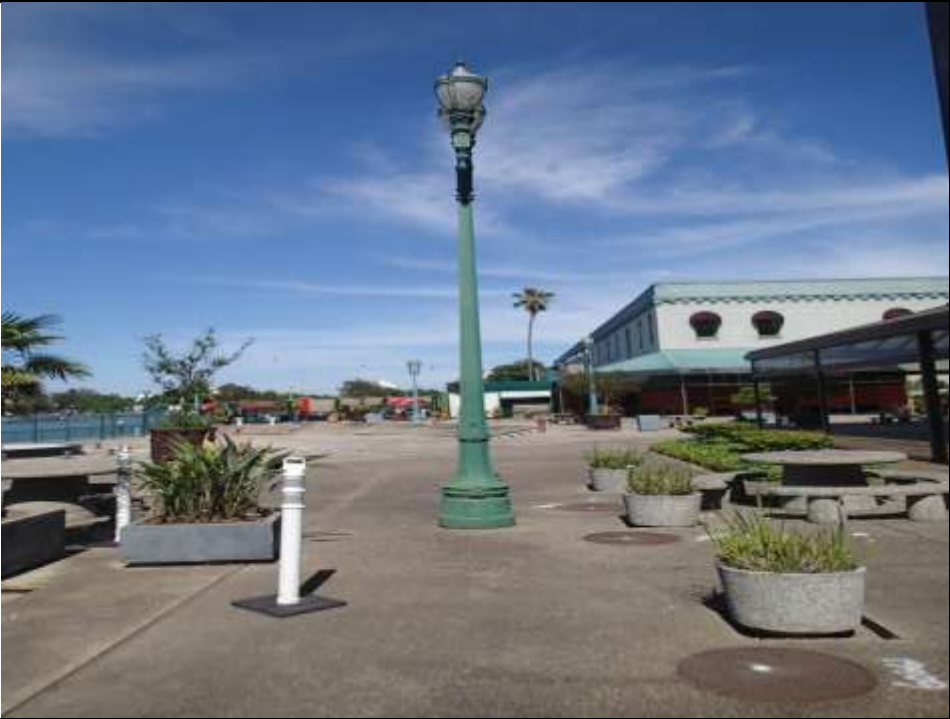
Client Name: City of Stockton	Site Location: 501 and 509 West Weber Ave., Stockton, California	Project No.: 20-6023
Photo No. 15 Description: LBP - 509 West Weber Ave: Lamp Posts, Common Courtyard

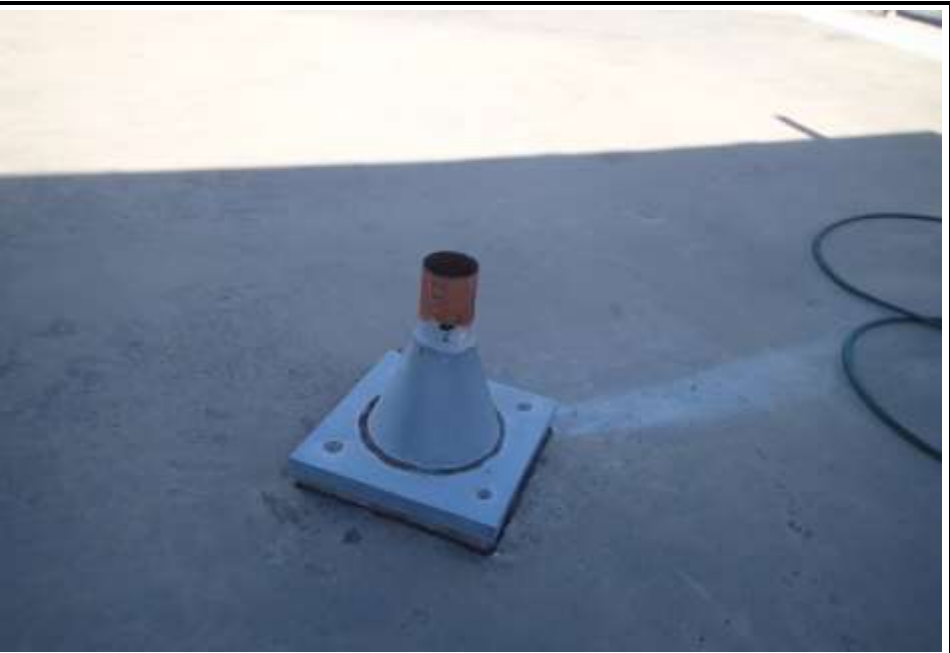
Photo No. 16 Description: ACM - 509 West Weber Ave: Sealant mastic (Black/Gray) on roof penetrations, skylights, HVAC duct penetrations and duct sealant

Results of bulk sample analysis confirmed that ACMs are present at the Site in various forms and building applications. The non-friable ACM identified were found to be in good to fair condition at the time of this asbestos survey. In accordance with federal, state and local regulations, ACMs must be removed by a licensed asbestos abatement contractor from the structures prior to demolition or renovation activities that would disturb the ACMs.

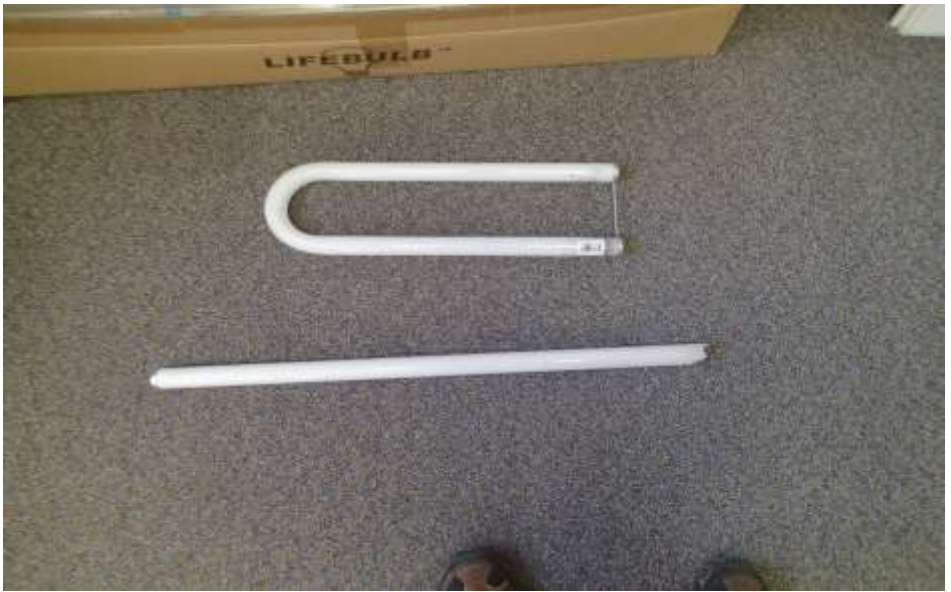
Photo No. 20

Description: UWM – 501 & 509 West Weber Ave: Florescent Tube Lights (Various Lengths)

The contractor should characterize all waste streams by laboratory testing and verification for the presence/absence of known hazardous substances prior to waste hauling and disposal. Regulated wastes should be properly packaged, labeled and stored in locked/secured areas or within secured facilities until they are hauled from the site. Properly trained worker personal (e.g. 40-hour HAZWOPER) should be employed to remove, handle, and package universal wastes for proper disposal or recycling.

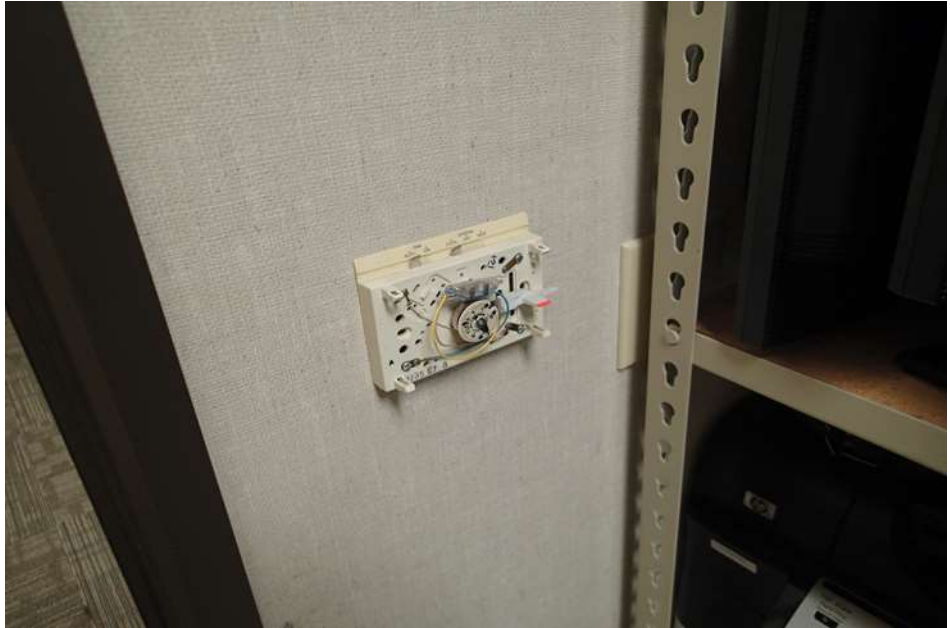
Client Name: City of Stockton	Site Location: 501 and 509 West Weber Ave., Stockton, California	Project No.: 20-6023
Photo No. 21 Description: UWM – 501 West Weber Ave: Mercury capsules in Thermostats

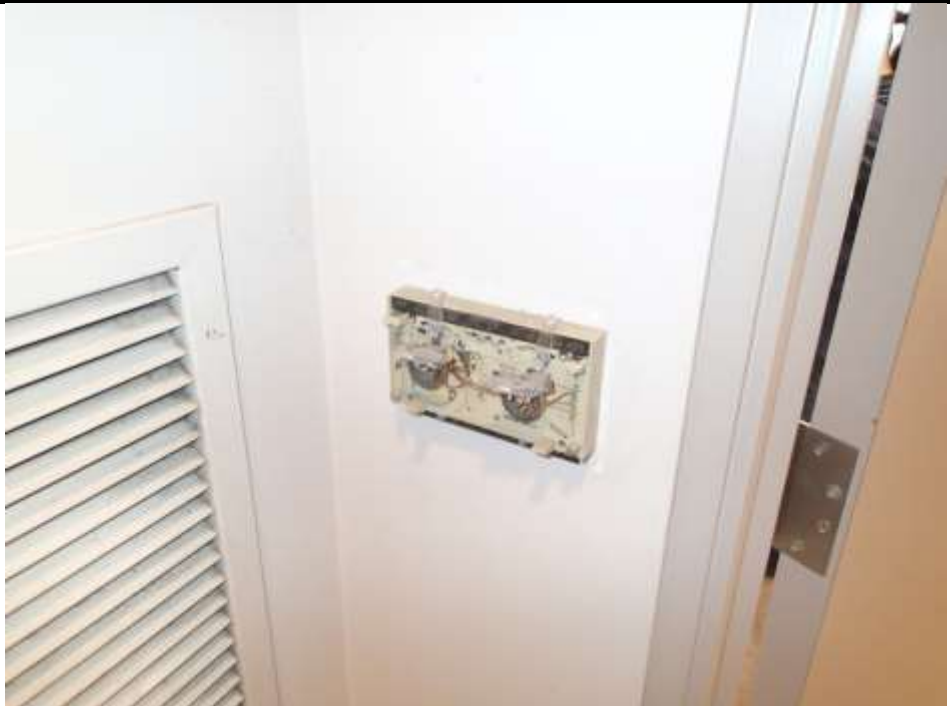
Photo No. 22 Description: UWM – 509 West Weber Ave: Mercury capsules in Thermostats
