ALEXANDRIA AND FIVE MILE SLOUGH CULVERT REPLACEMENT STOCKTON, CALIFORNIA

GEOTECHNICAL EXPLORATION

PREPARED BY
ENGEO Incorporated

PROJECT NO.
19161.000.001

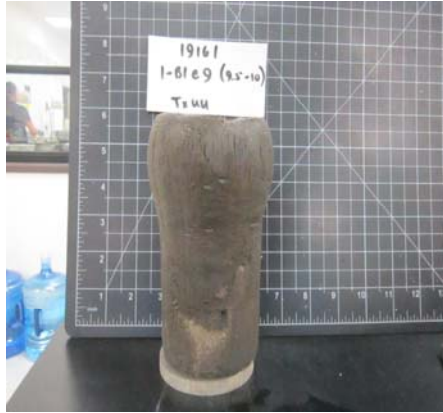
SPECIMEN PHOTOS

SAMPLE NUMBER: 1-B1@9

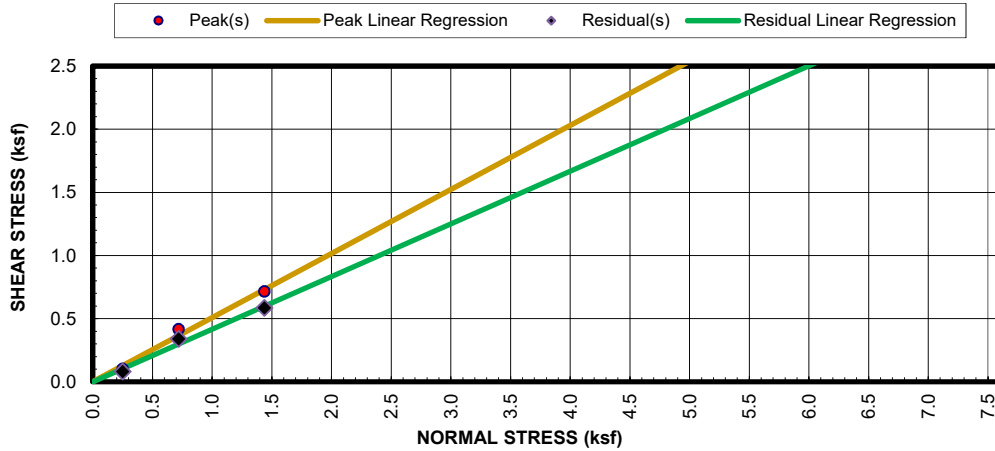
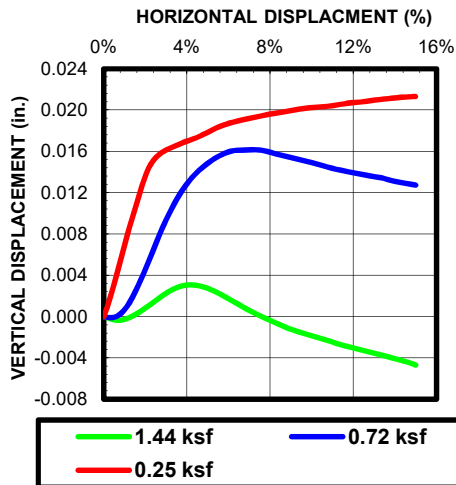
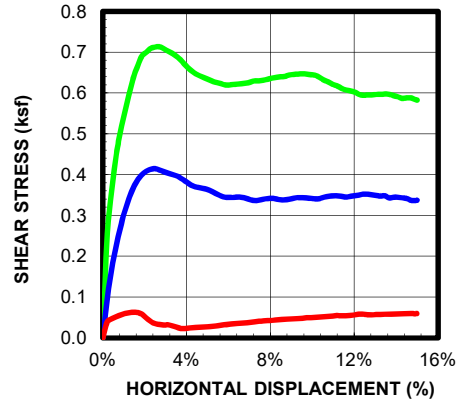
CONSOLIDATED DRAINED DIRECT SHEAR ASTM D3080

SPECIMEN			
INITIAL PARAMETERS	1.44 ksf	0.72 ksf	0.25 ksf
MOISTURE (%)	18.72	25.86	24.25
DRY DENSITY (PCF)	101.85	98.84	95.58
VOID RATIO	0.657	0.749	0.801
SATURATION (%)	77.06	95.59	83.47
DIAMETER (IN.)	2.415	2.415	2.415
HEIGHT (IN.)	1.002	0.996	1.013
DIAMETER-TO-HEIGHT RATIO	2.411	2.424	2.384
SPECIFIC GRAVITY (ASTM D854)	2.703	2.770	2.758
FINAL PARAMETERS	1.44 ksf	0.72 ksf	0.25 ksf
MOISTURE (%)	23.29	27.12	29.15
DRY DENSITY (PCF)	103.56	98.75	95.44
VOID RATIO	0.629	0.751	0.804
SATURATION (%)	100.00	99.99	100.00
DIAMETER (IN.)	2.415	2.415	2.415
HEIGHT (IN.)	0.980	0.988	1.013
NORMAL STRESS (ksf)	1.44	0.72	0.25
PEAK STRESS (ksf)	0.71	0.41	0.06
PEAK STRAIN (%)	2.69	2.48	1.45
RESIDUAL STRESS (ksf)	0.58	0.34	0.06
RESIDUAL STRAIN (%)	15.00	15.00	14.99
RATE (IN/MIN)	0.00181	0.00181	0.00181
DIAMETER-TO-HEIGHT RATIO	2.465	2.445	2.385

SPECIMEN INFORMATION		STRENGTH PARAMETERS		ϕ°	C(ksf)
SAMPLE ID:	1-B1@5.5	PEAK:	26.9	0.00	
DEPTH (ft):	5.5 feet	RESIDUAL:	22.6	0.00	
SAMPLE TYPE:	In-situ	ASTM D4318			
DESCRIPTION:	See exploration logs	LIQUID LIMIT:	n/a		
		PLASTIC LIMIT:	n/a		
REMARKS:	Consolidation data inconclusive. Default shear rate used.
